NATIONAL TRANSPORTATION SAFETY BOARD

Group Chairman's Factual Report

DCA13MA120

Addendum to Structures Factual Report- Fuel Tanks

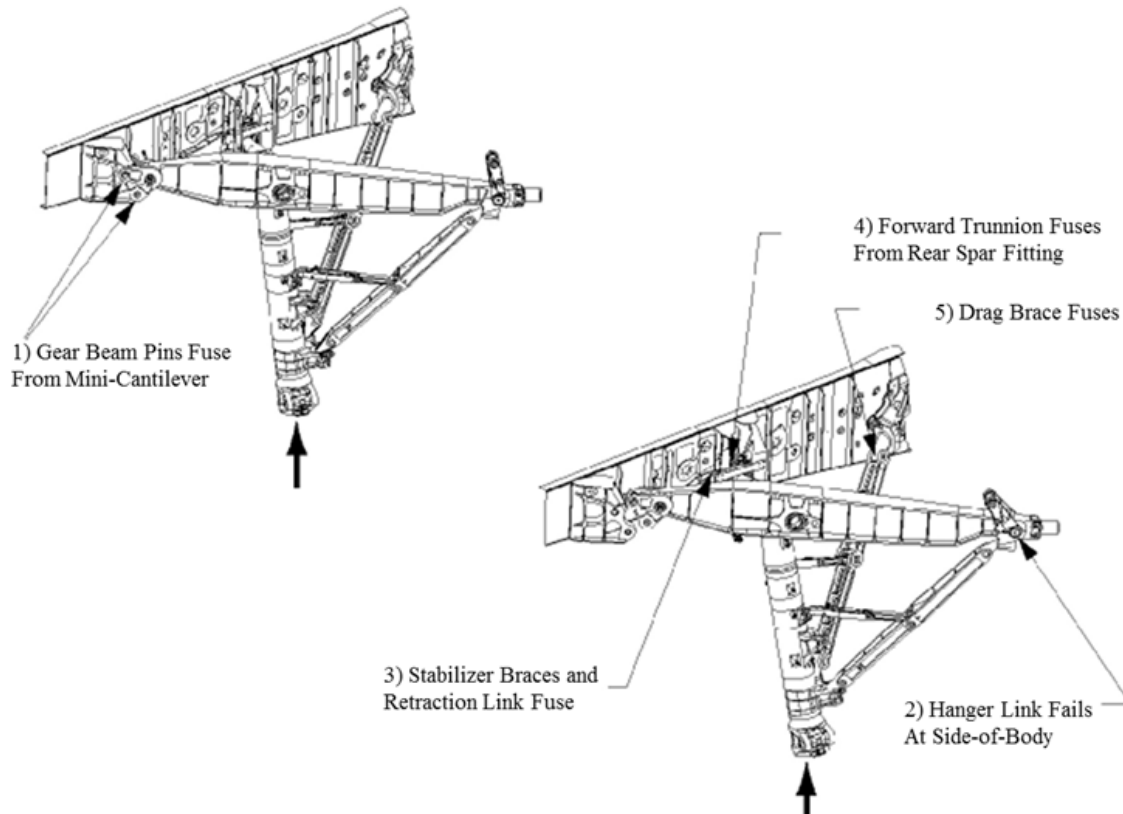
777 Vertically Dominated Main Landing Gear Breakaway Scenario

In the event of a main landing gear breakaway event, the 777 airplane main landing gear is designed to separate according to a prescribed sequence. The sequence for a vertically-dominated event differs from a drag-dominated event. The observations made at the accident scene, as well as the evidence gathered from the airplane, indicate that this was a breakaway event dominated by a vertical gear overload. The relatively low forward velocity of the aircraft, combined with the high sink rate and angle of attack also support this finding. Both the left hand and right hand landing gears exhibited similar damage and the physical evidence indicated that the failures occurred per the designed scenario.
